PASSAIC RIVER BASIN  
INDIA BROOK, MORRIS COUNTY  
NEW JERSEY

# CHEROKEE LAKE DAM NJ 00785

PHASE 1 INSPECTION REPORT  
NATIONAL DAM SAFETY PROGRAM

MAY 1981

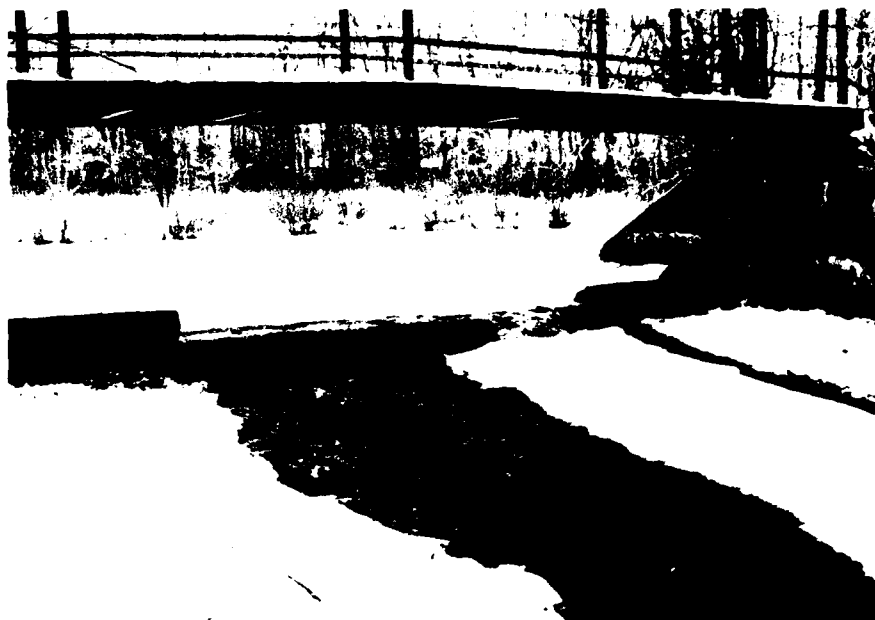
PHOTO 1

The general condition of the spillway was deteriorated. The primary stage of the weir, which consisted of a cut in its center, was considerably eroded and spalled due to overflow. The secondary stage appeared to be in generally satisfactory condition. At the downstream end of the apron, the discharge drops about 4 feet to a stilling basin below. The stilling basin contained a significant amount of debris, although some of it was obscured by considerable amounts of ice and snow. The timber sheetpile cutoff wall under the downstream end of the apron was mostly obscured by ice and snow. The left training wall was very deteriorated. The upstream end of the training wall at the waterline was completely eroded and spalled so that the upstream end is suspended with two reinforcing rods protruding from it down to the waterline. There was also considerable spalling over about 50 percent of the inside surface of the training wall. Also the edge of the training wall along the downstream side at the top was considerably spalled.

CREST OF SPILLWAY

(3) The spillway structure should be thoroughly inspected with the lake drawn down. Spalled and deteriorated portions of the concrete should be repaired.

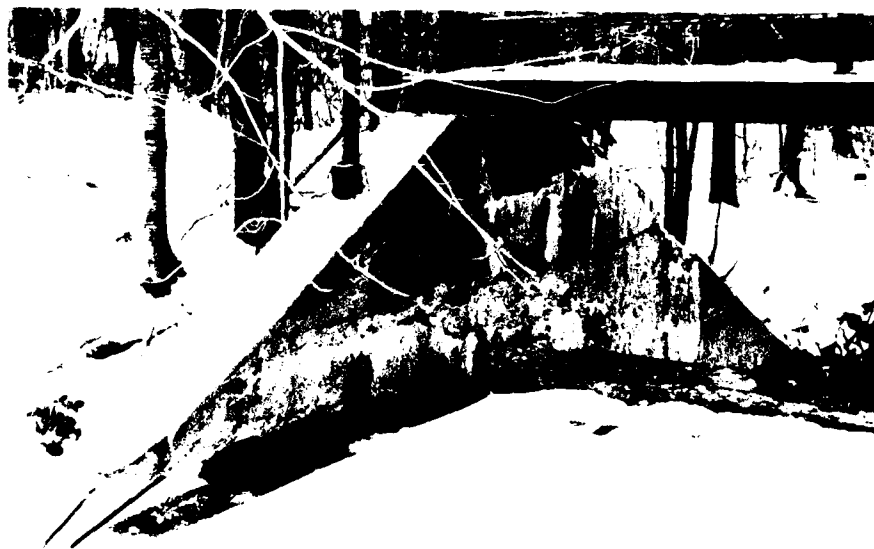
PHOTO 4

LEFT SPILLWAY TRAINING WALL

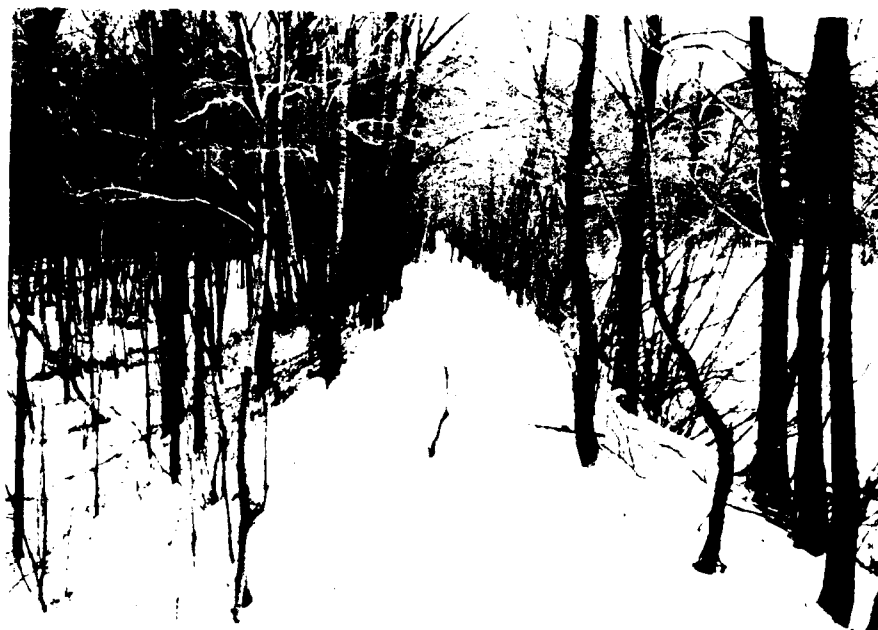
PHOTO 5  
CREST OF DAM

The lower portion of the embankment crest appeared to be the same portion noted by the State Water Policy Commission in 1948 as having settled.

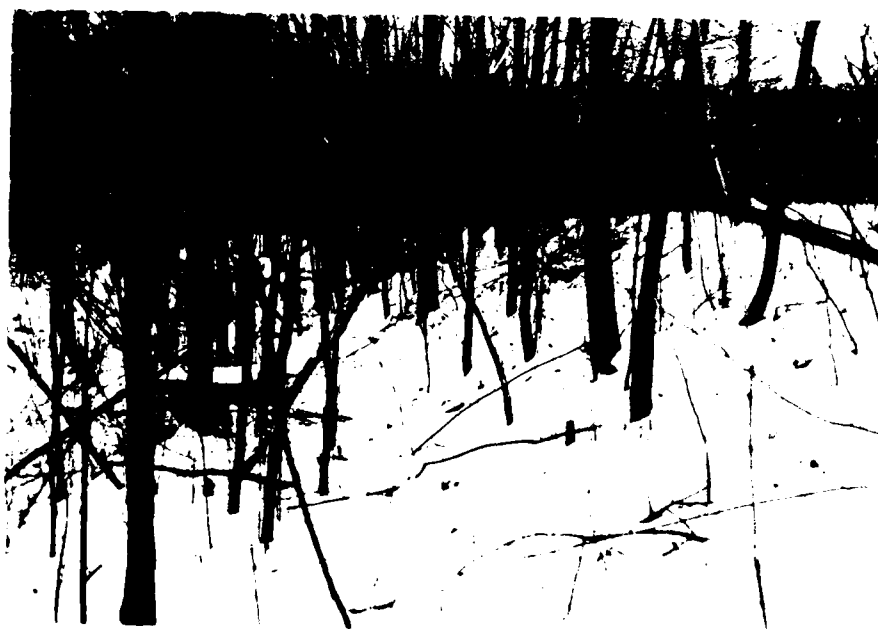
PHOTO 6  
DOWNSTREAM FACE OF DAM

Seepage was observed at two locations along the toe of dam right of the outlet works. The seepage was in the form of wet spongy areas with standing water. The standing water was not frozen although the lake water was frozen. One area of standing water approximately 40 feet right of the outlet works had dimensions of 5 feet wide and 8 feet long, while the other area was about 1 foot square.

(8) The two areas of seepage observed at the toe of the dam should be monitored in order to detect any changes in their condition.

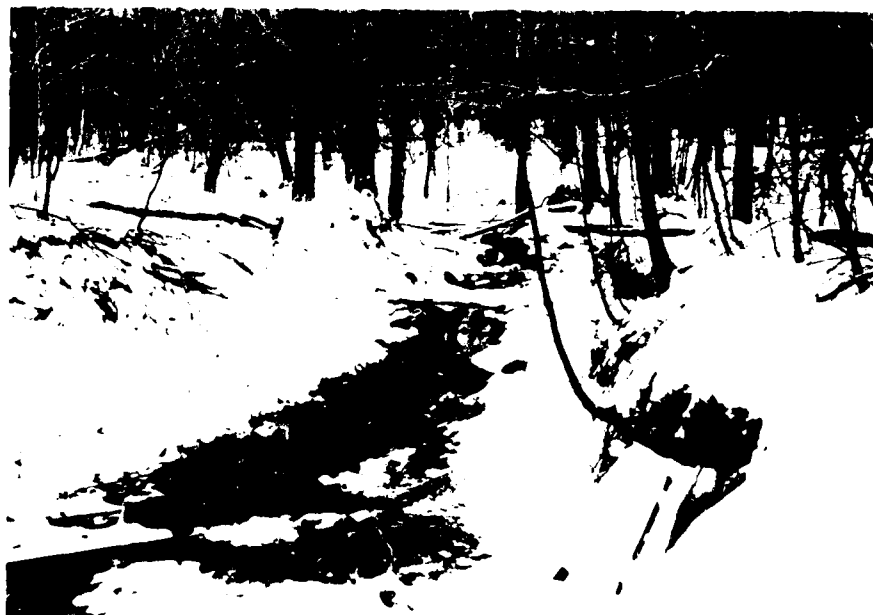
PHOTO 10

the spillway and between the spillway and the confluence there was evidence of significant erosion on the banks of the downstream channel. Soil had been loosened and roots of trees exposed. Also, erosion was observed on the bank of the diversion channel at its bend point at the right end of the dam. The top of the erosion was approximately 2 1/2 to 3 feet above the invert of the stream, indicating occasional high flow.

DOWNSTREAM CHANNEL
